**SURFACE-CHEMISTRY-DRIVEN TRIBOLOGICAL FUNDAMENTALS
OF DIAMOND AND SIC FOR EXTREME ENVIRONMENT
MEMS APPLICATIONS**

Final Report for the Period 01 August 2000 to 31 December 2000
AFOSR Contract No. FA9620-98-C-0009

Submitted by:
Engineering Services Center (ESC)
Sensors Engineering (SE)
Raytheon Electronic Systems (RES)
El Segundo, CA 90245

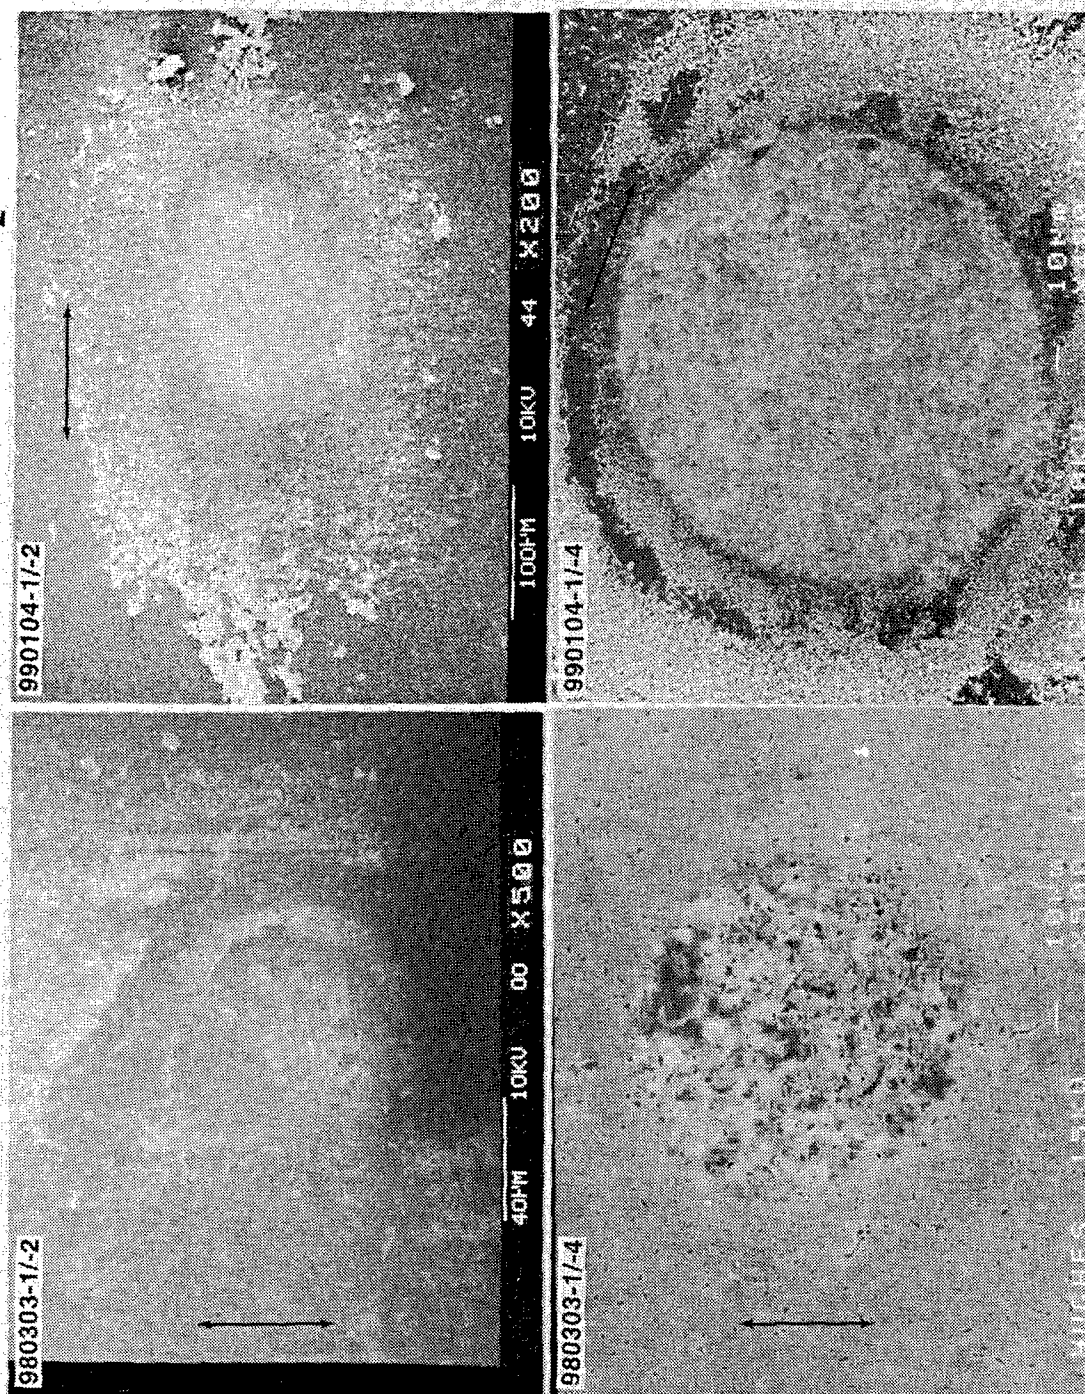
Figure 3. Normal incidence SEM photomicrographs of hexane+HF-washed Hexoloy SiC pin wear scars, as-tested in 0.2 and 3.4 Torr P_{O₂}; double-headed arrows indicate direction of sliding.

⁽¹⁾Wear rate could not be estimated due to poor wear scar definition in Figure 3.

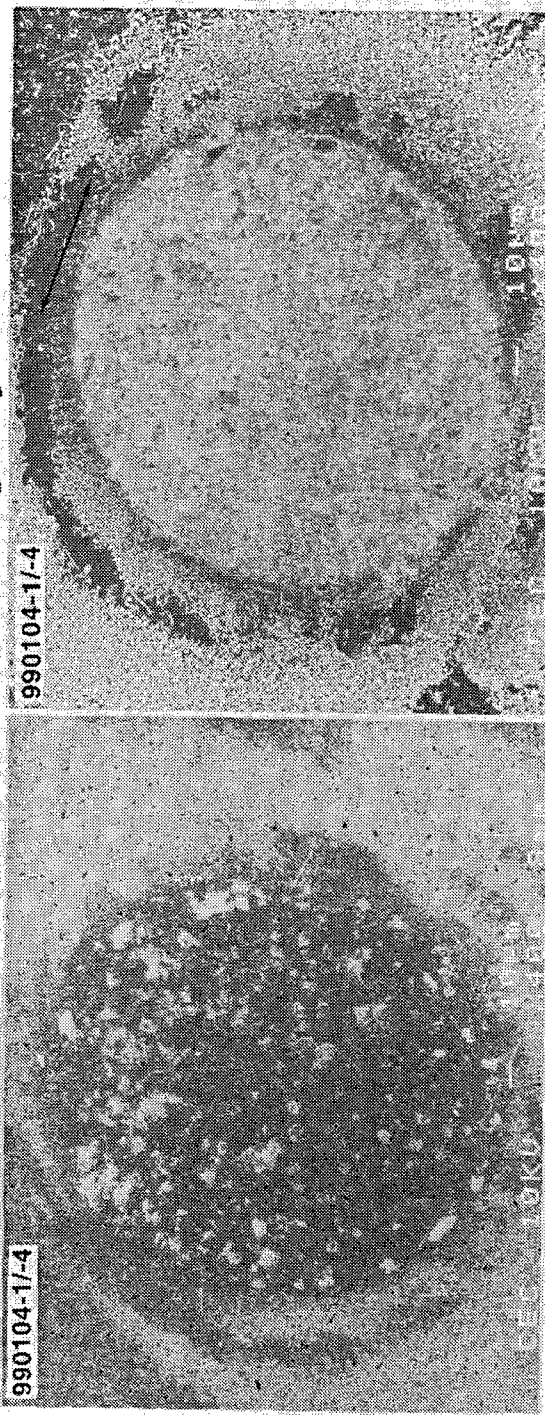
Figure 4. SEM photomicrographs of hexane+HF-washed Hexoloy SiC pin wear scar and wear debris, as-tested in 3.4 Torr PO₂; photo taken on-centerline (left) and slightly off-centerline (right) to show ovality of the scar as a function of photo angle.

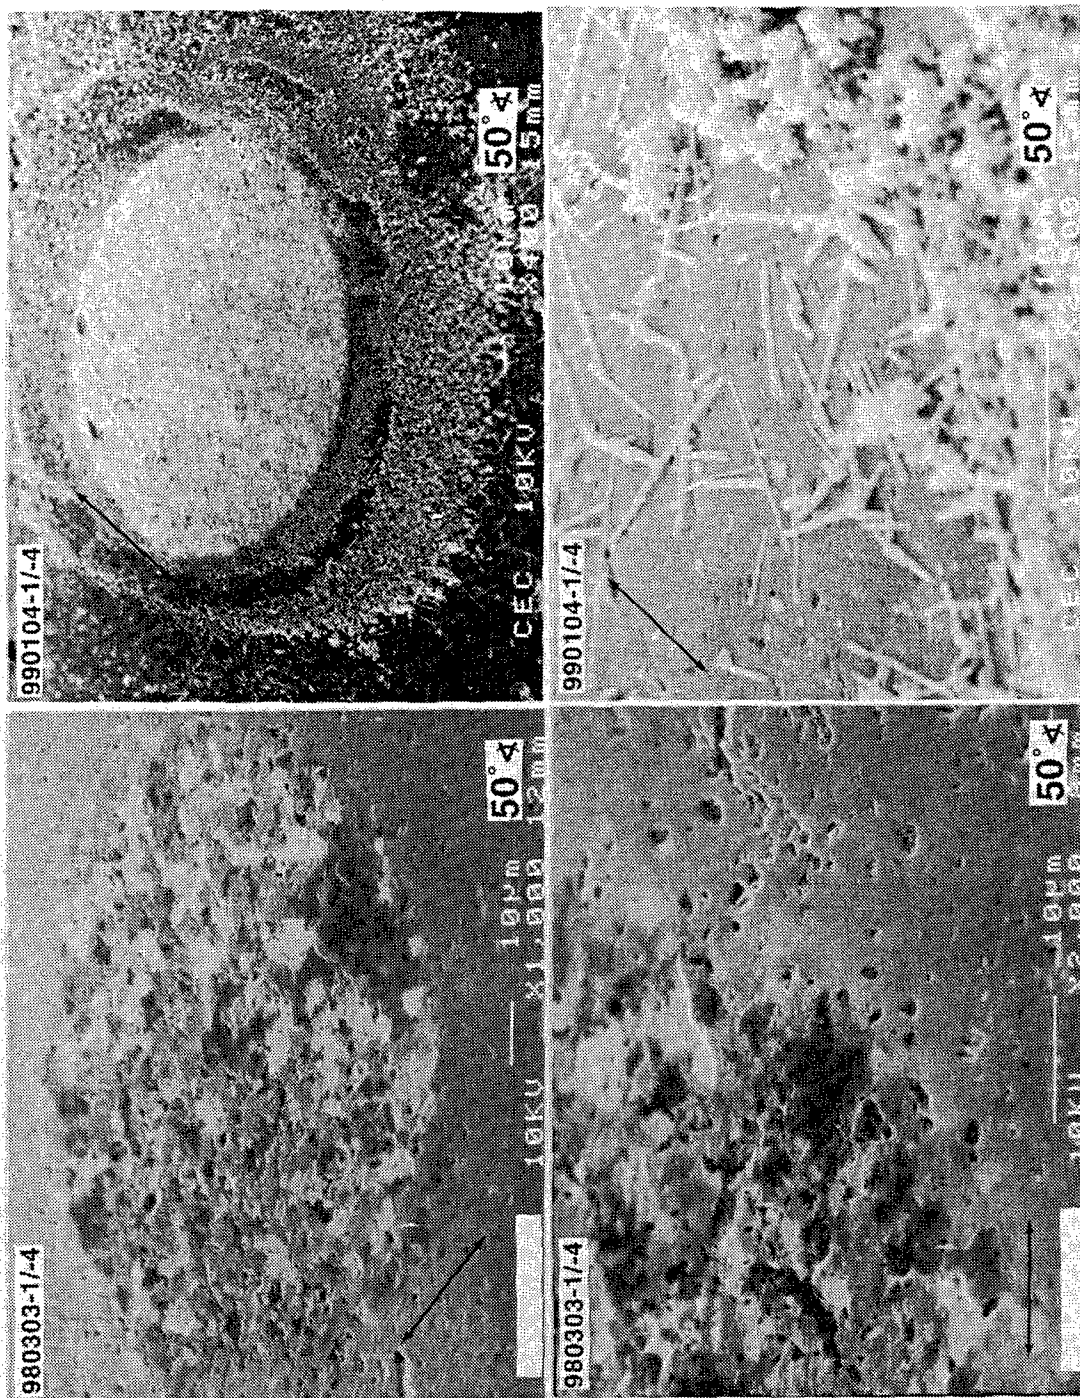
Figure 5. Shallow angle SEM photomicrographs of the hexane+HF-washed Hexoloy SiC pin wear scar edge, as-tested in 0.2 Torr and 3.4 Torr P_{O₂}, showing the scar texture and wear debris morphologies, at various magnifications. Double-headed arrows indicate direction of sliding.

The wear rates (\mathcal{W}) in Table 1 were calculated per Figure 5. The values, compared with those of SiC-B from [1] (Table 2) indicate that the tribooxidative kinetics of the two materials are very close, with a somewhat lower rate for the more oxidation resistant Hexoloy, its porosity notwithstanding. The \mathcal{W} are about an order of magnitude greater than those of polished PCD. As also shown in Figure 5, the wear scar is textured and there is some frosting, along with the evidence of the ubiquitous porosity of the pressureless-sintered Hexoloy. However, the scars associated with both partial pressures of oxygen are far smoother than those observed after the vacuum tests in [1]. The partially oxidized flat scars and the characteristic debris shapes described in Figures 6 through 10 show the following:

The bright- and dark-contrasted areas observed in the SEM images in Figure 5 were not seen in the SAM images in Figure 11. The analyses of the various sites indicated in the latter illustration yielded data similar to the AES/XPS of the SiC-B presented previously in [1]:

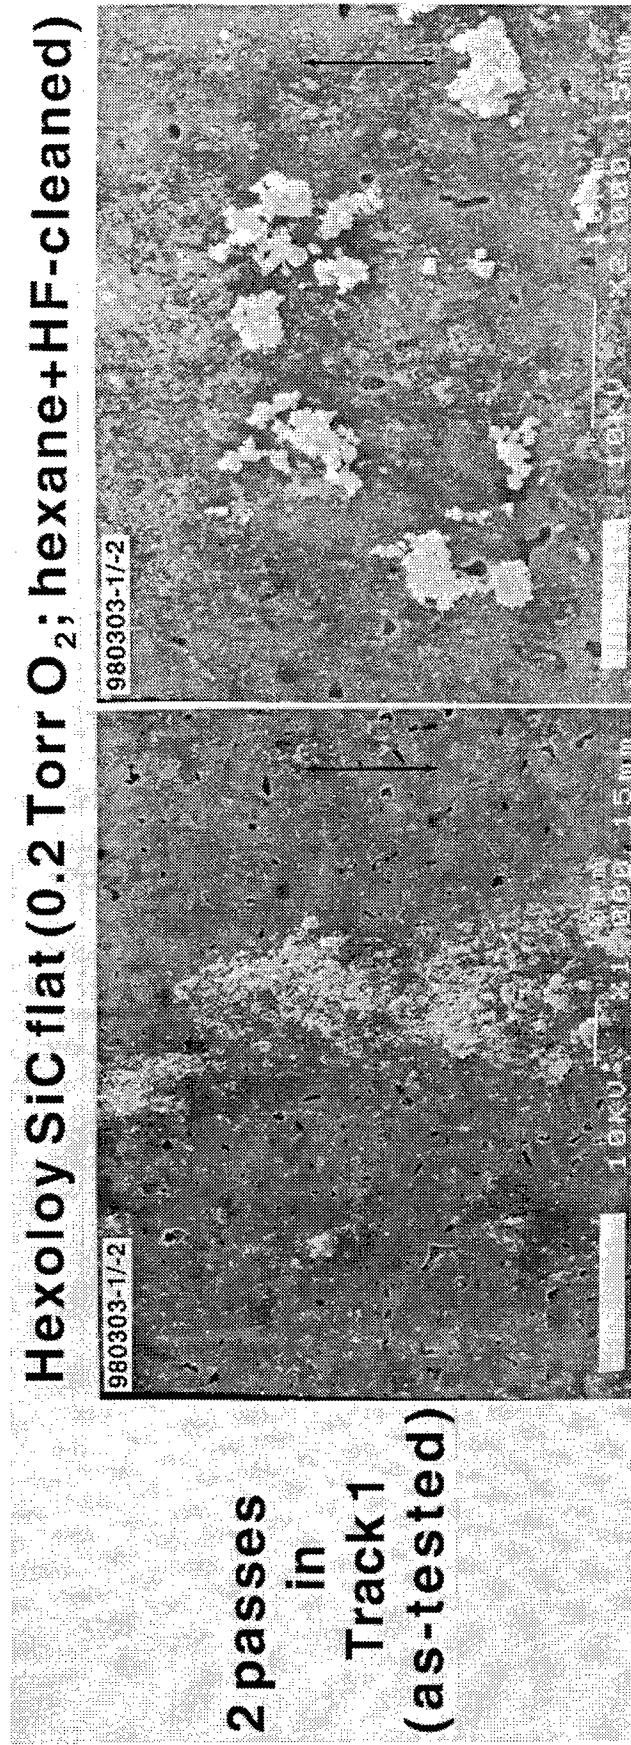
Figure 6. Normal incidence SEM photomicrographs of hexane+HF-washed Hexoloy SiC flat wear scars, as-tested in 0.2 Torr PO₂, showing early scar texture and wear debris morphologies; double-headed arrows indicate direction of sliding.

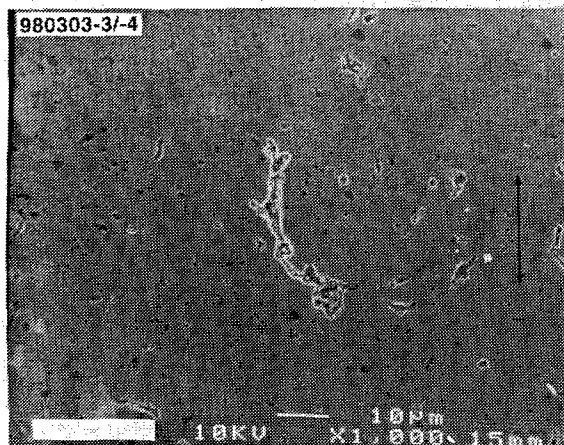
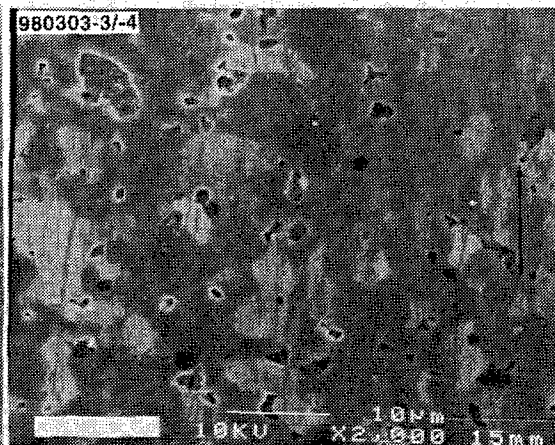
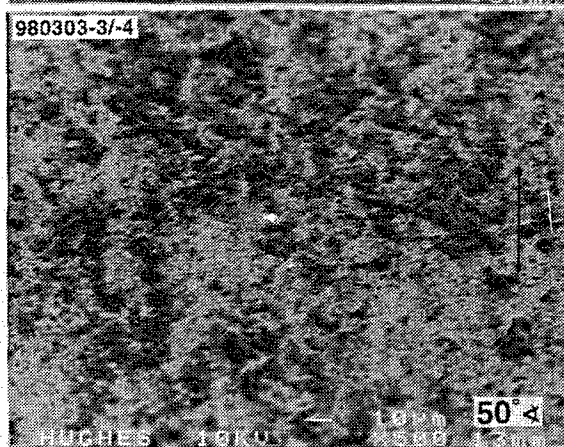
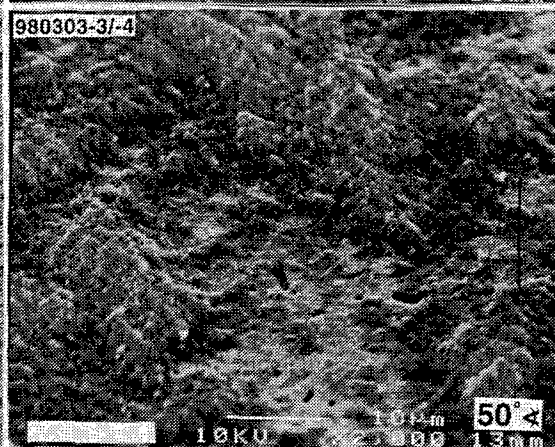
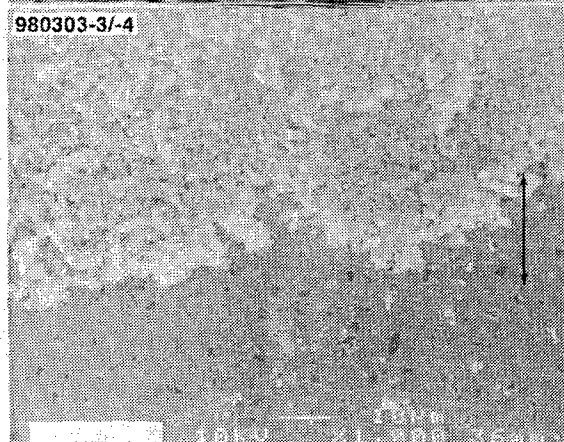
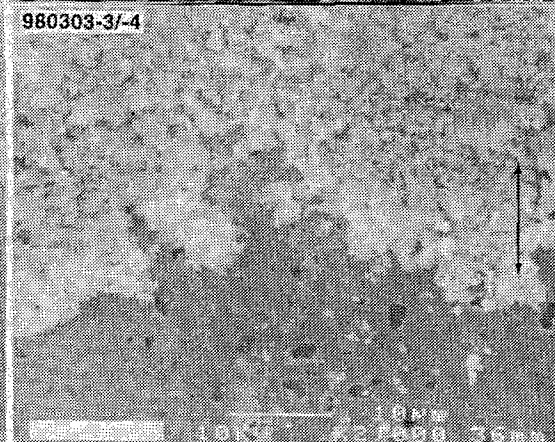
Figure 7. Normal incidence SEM photomicrographs of hexane+HF-washed Hexoloy SiC flat wear scars, as-tested in 0.2 Torr P_O₂, showing mature scar textures and wear debris morphologies; double-headed arrows indicate direction of sliding.

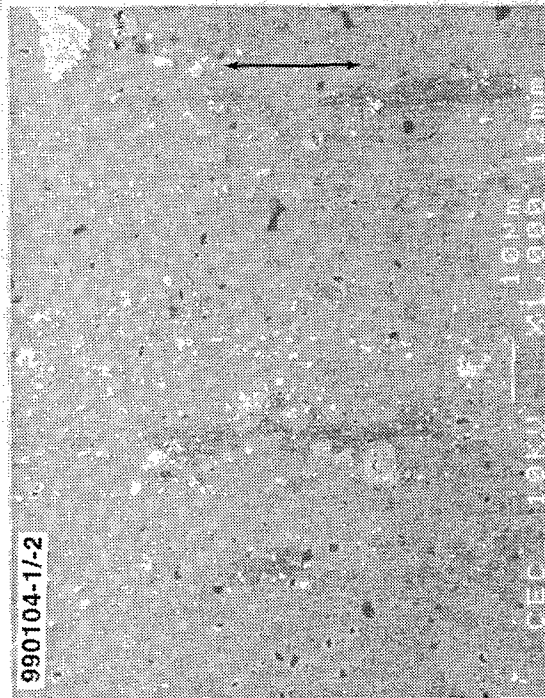
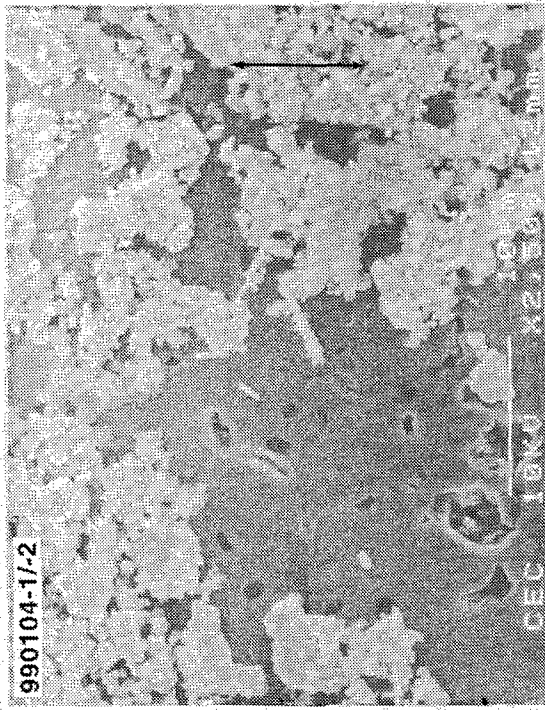
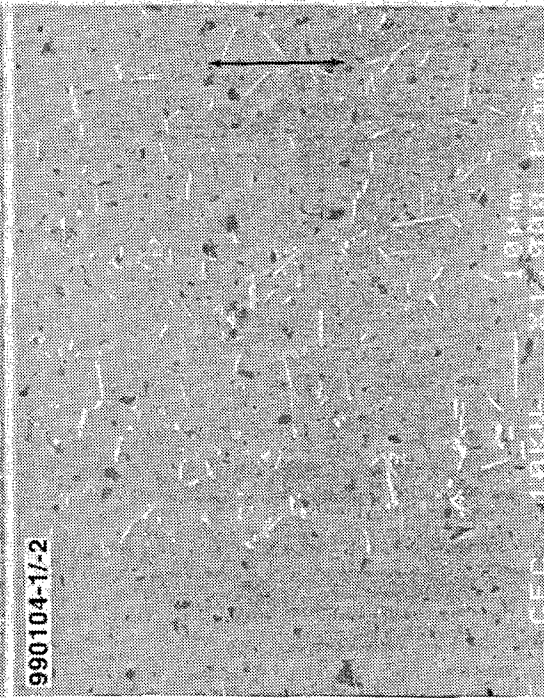
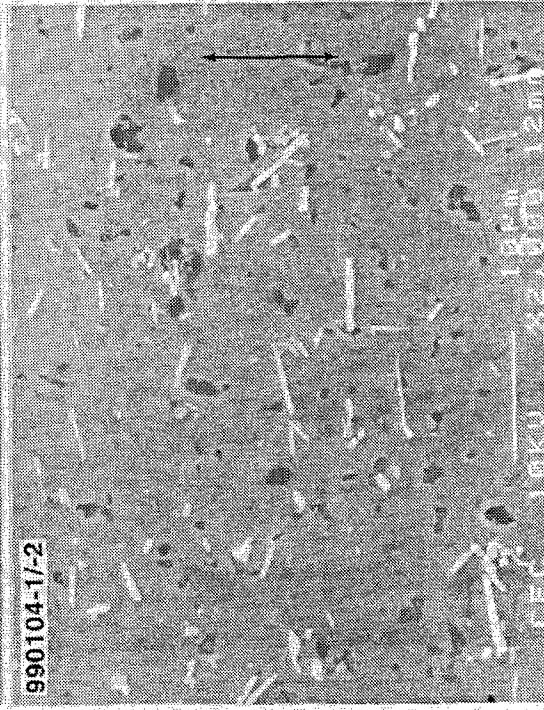
Figure 8. Normal incidence SEM photomicrographs of hexane+HF-washed Hexoloy SiC flat wear scars, as-tested in 3.4 Torr PO₂, showing early scar textures and wear debris morphologies; double-headed arrows indicate direction of sliding.

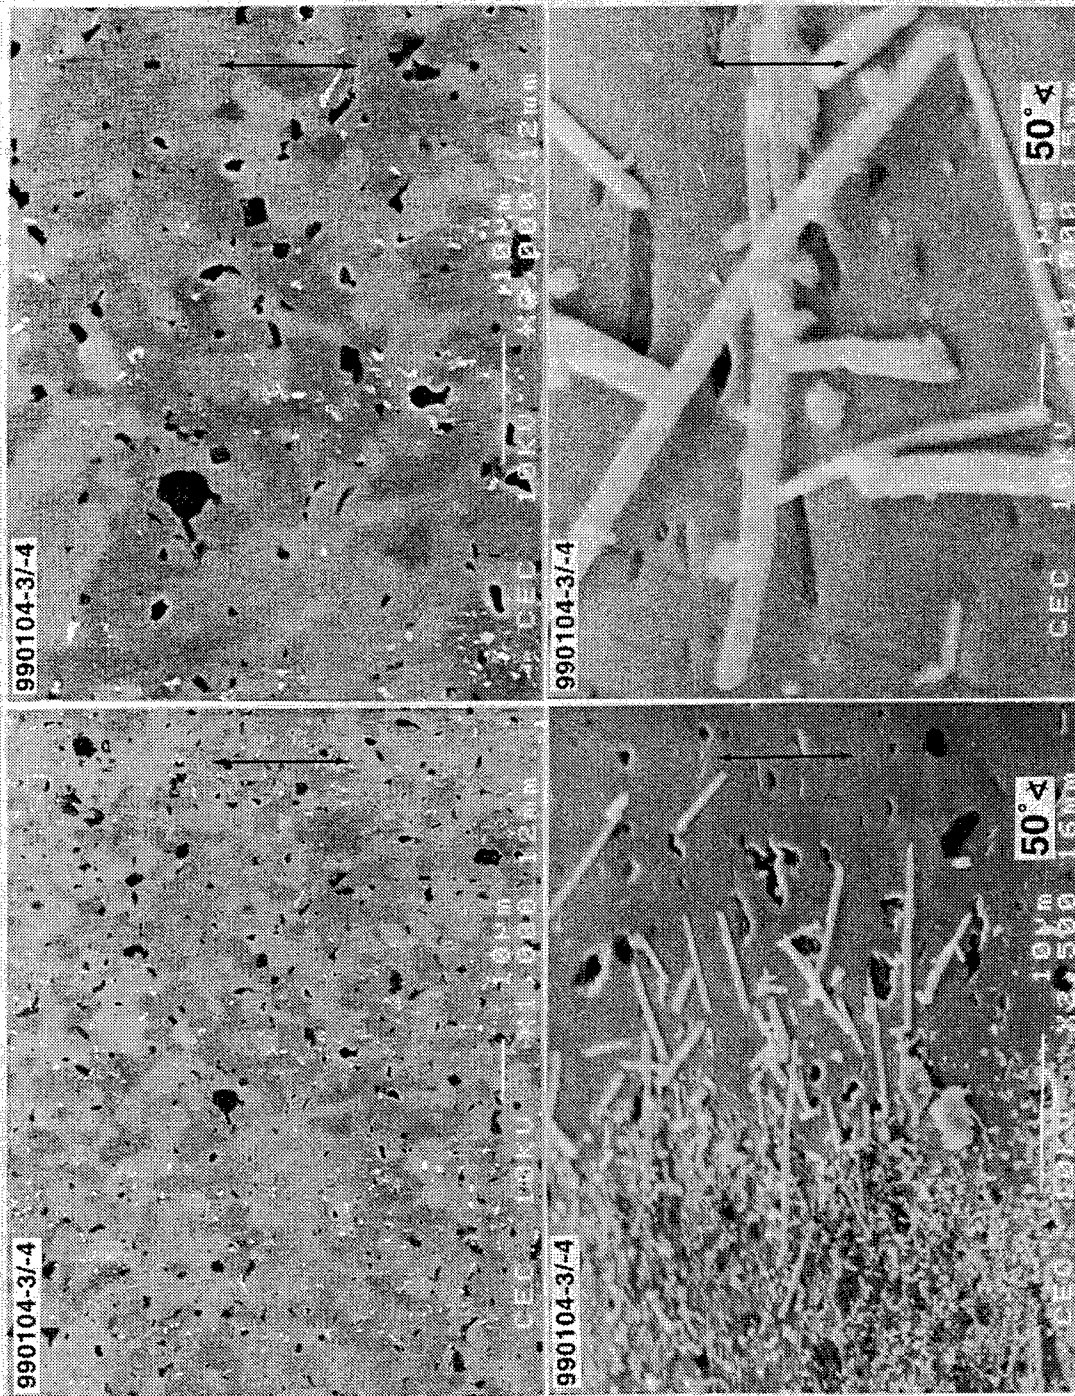
Figure 9. Normal incidence SEM photomicrographs of hexane+HF-washed Hexoloy SiC flat wear scars, as-tested in 3.4 Torr P_{O₂}, showing mature scar textures and wear debris morphologies; double-headed arrows indicate direction of sliding.

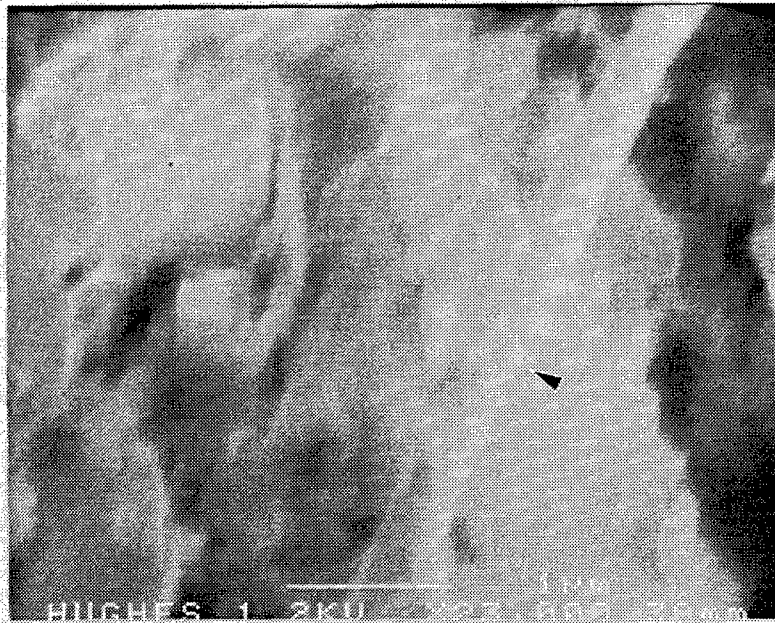
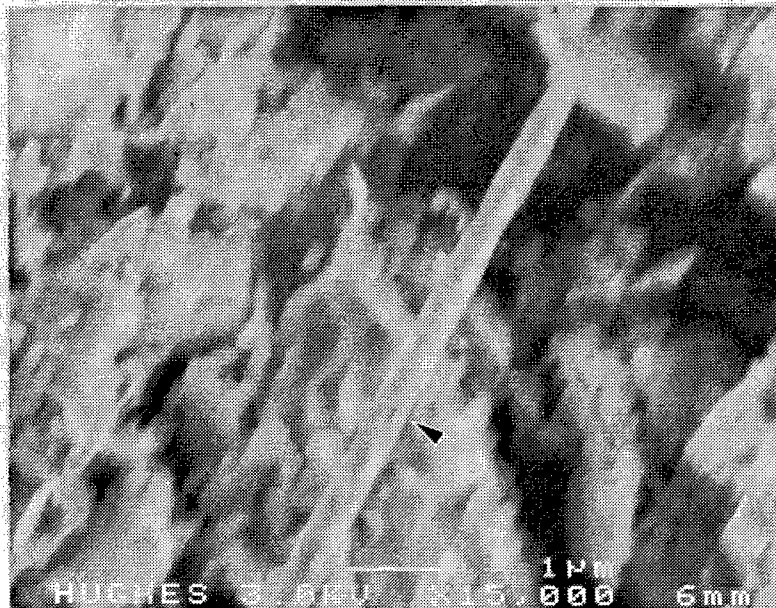
Figure 10. Similarities in the "rolling pin" wear debris appearance of Hexoloy SiC and CERCOM SiC-B.

2. The wear debris has two characteristic shapes, i.e., consolidated platelets and rod-like "rolling pins", at both partial pressures. However, there is a far greater prevalence of the micro-rolls at 3.4 Torr. The photo in Figure 10 indicates that the formation mechanism of these rolling pins on both SiC-B [1] and Hexoloy are identical: where the oxidation kinetics are fast enough to form enough viscous SiO_{2-x} on the surface to generate tiny rolls during sliding, they can form in greater numbers. Clearly, their formation in 0.2 Torr is severely retarded, because unevaporated (residual) SiO_x on the surface (if any at all, see the forthcoming surface-analytical results) is hard and brittle. Note that the larger number of rolls at 3.4 Torr coincides with the more effectively reduced friction at that pressure (see Figures 1 and 2), as previously discussed with SiC-B in [1].

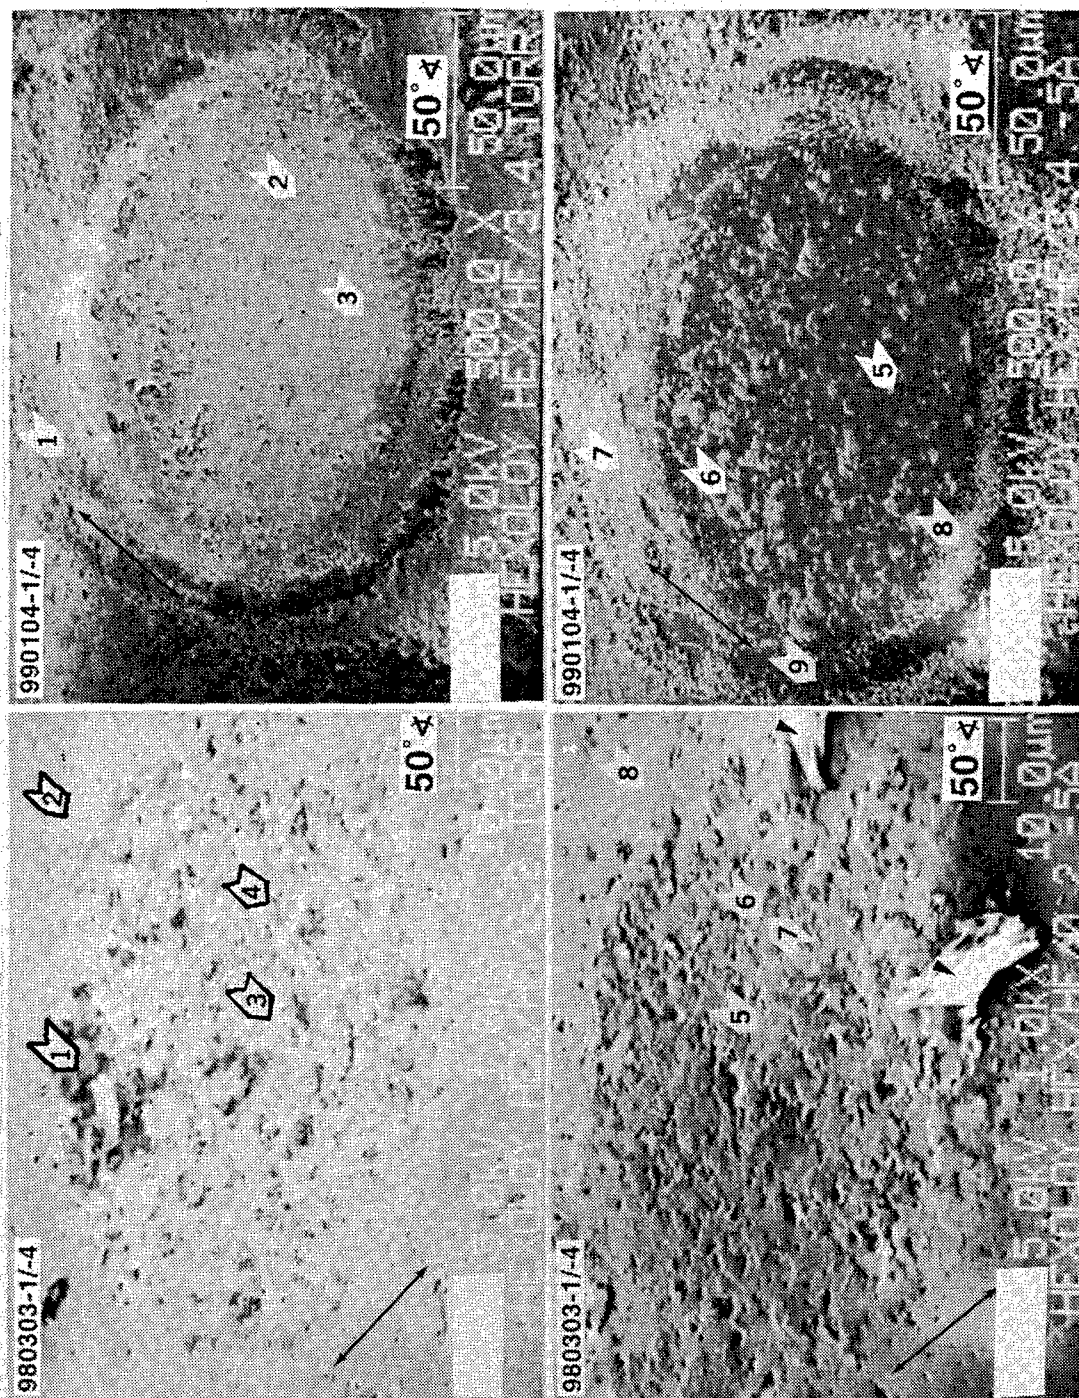
Figure 11. Shallow angle SAM photomicrographs of the hexane+HF-washed Hexoloy SiC pin wear scar, as-tested in 0.2 Torr and 3.4 Torr O₂ (arrows indicate analytical sites); various magnifications (also see Tables 3 and 4).

1. The near-absence of Si on the wear scar surface after the 0.2 Torr tests is real. Even though the smooth area (after the removal of a 5Å surface layer by sputtering) yielded a numerical value of 14 at.% for Si (see AES survey results in Table 3), this amount is at the noise level of the spectrum. The rough area shows just carbon, with oxygen appearing only in the subsurface in extremely small quantities. Even the unrubbed area next to the scar contained only some oxidized surface carbon - - no Si. The stoichiometry of the debris was that of SiO (an Si/O at.% ratio of 1), with a great deal of surface carbon.

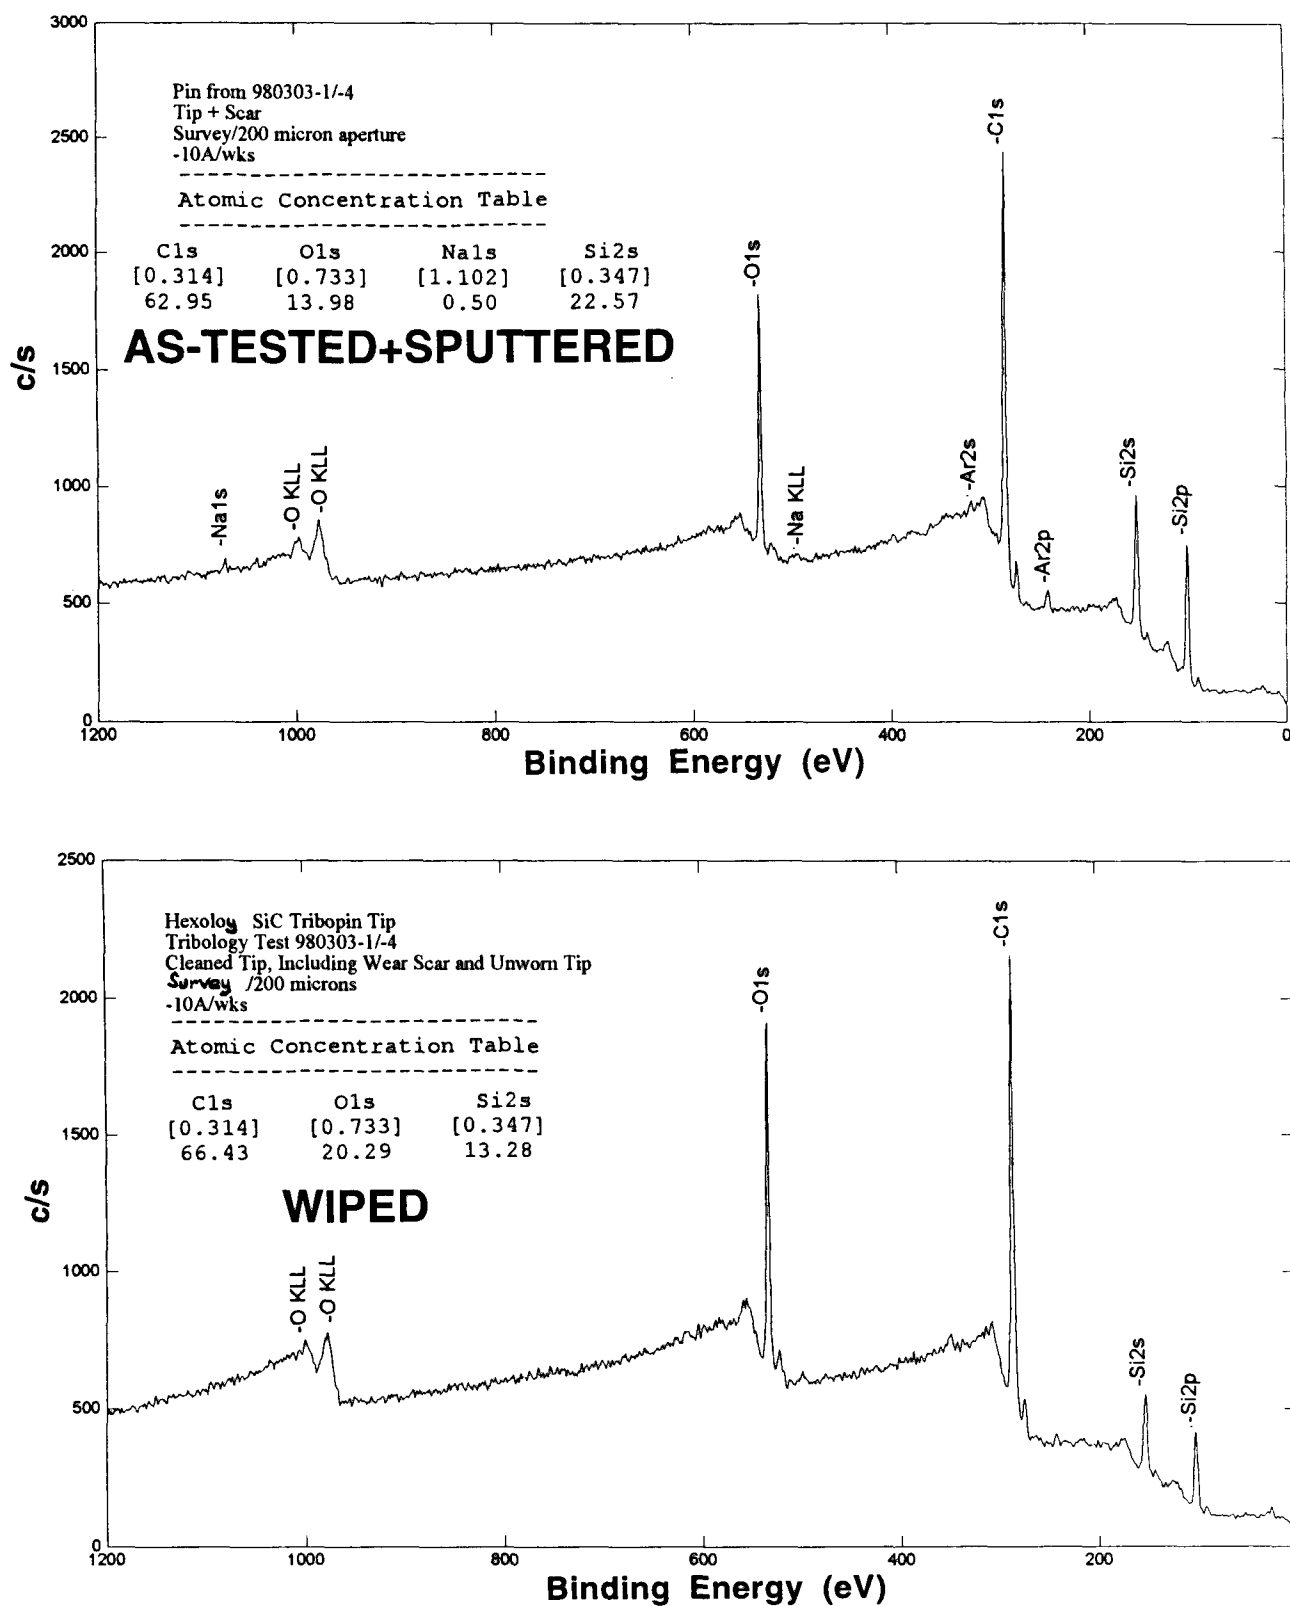
Figure 12. Wide-scan survey XPS spectra of the hexane+HF-washed and 0.2 Torr PO_2 -tested Hexoloy SiC pin tip wear scar, in the as-tested+Ar-sputtered (top) and wiped+Ar-sputtered (bottom) conditions; also see Table 3. Ar-sputtering removed 1 nm in each case.

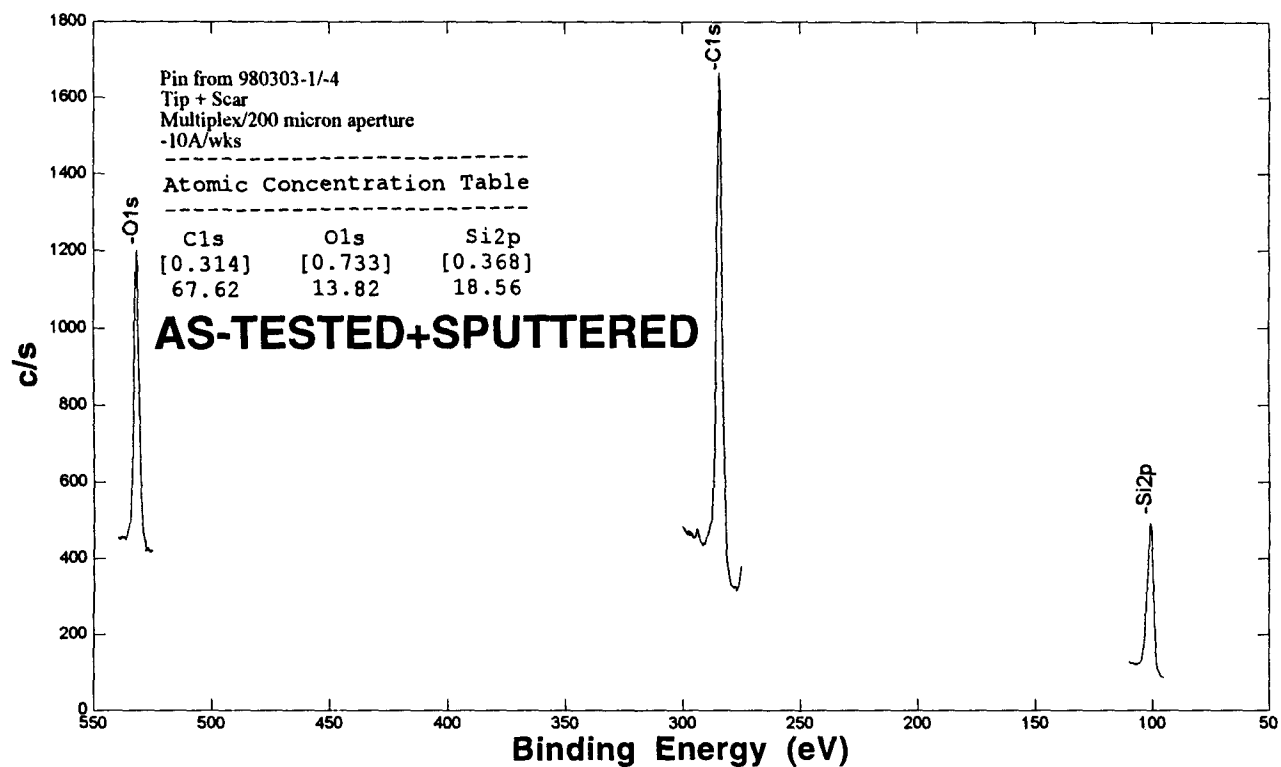
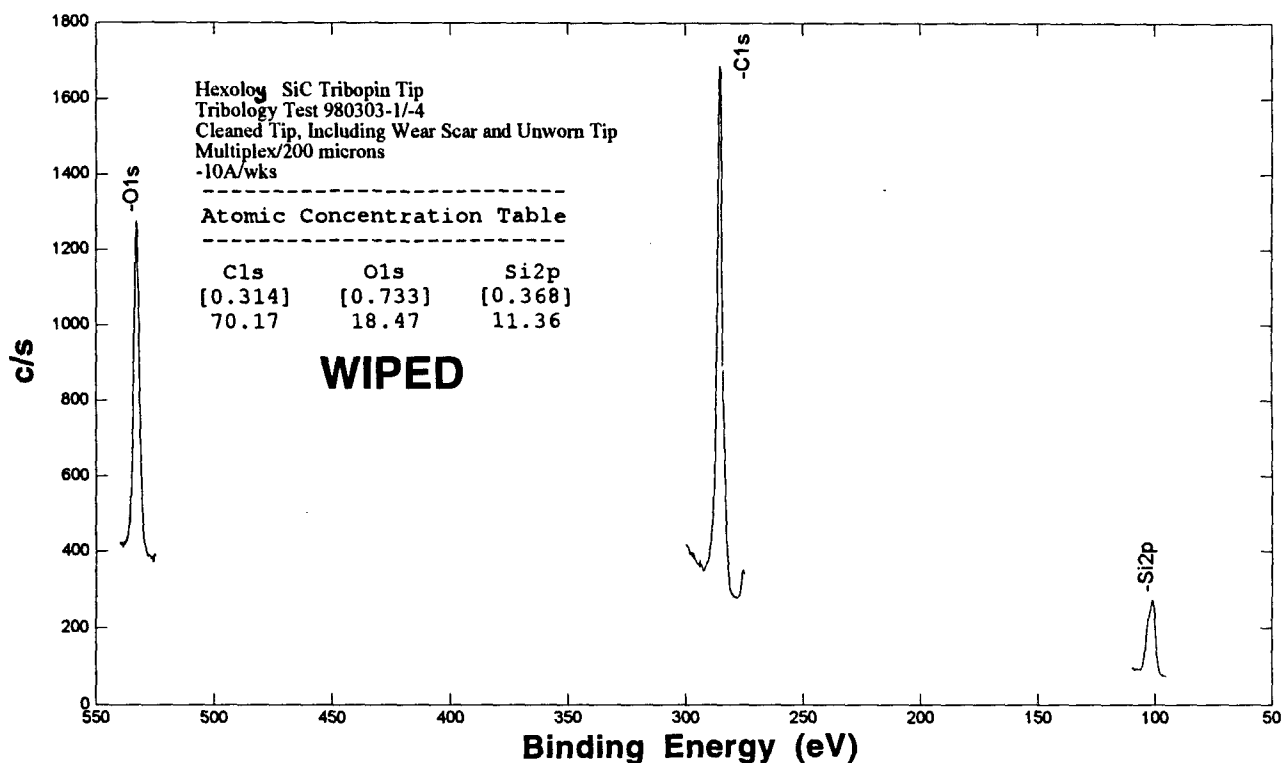
Figure 13. Multiplexed XPS spectra of the hexane+HF-washed and 0.2 Torr PO₂-tested Hexoloy SiC pin tip wear scar, in the as-tested+Ar-sputtered (top) and wiped+Ar-sputtered (bottom) conditions; also see Table 3. Ar-sputtering removed 1 nm in each case.

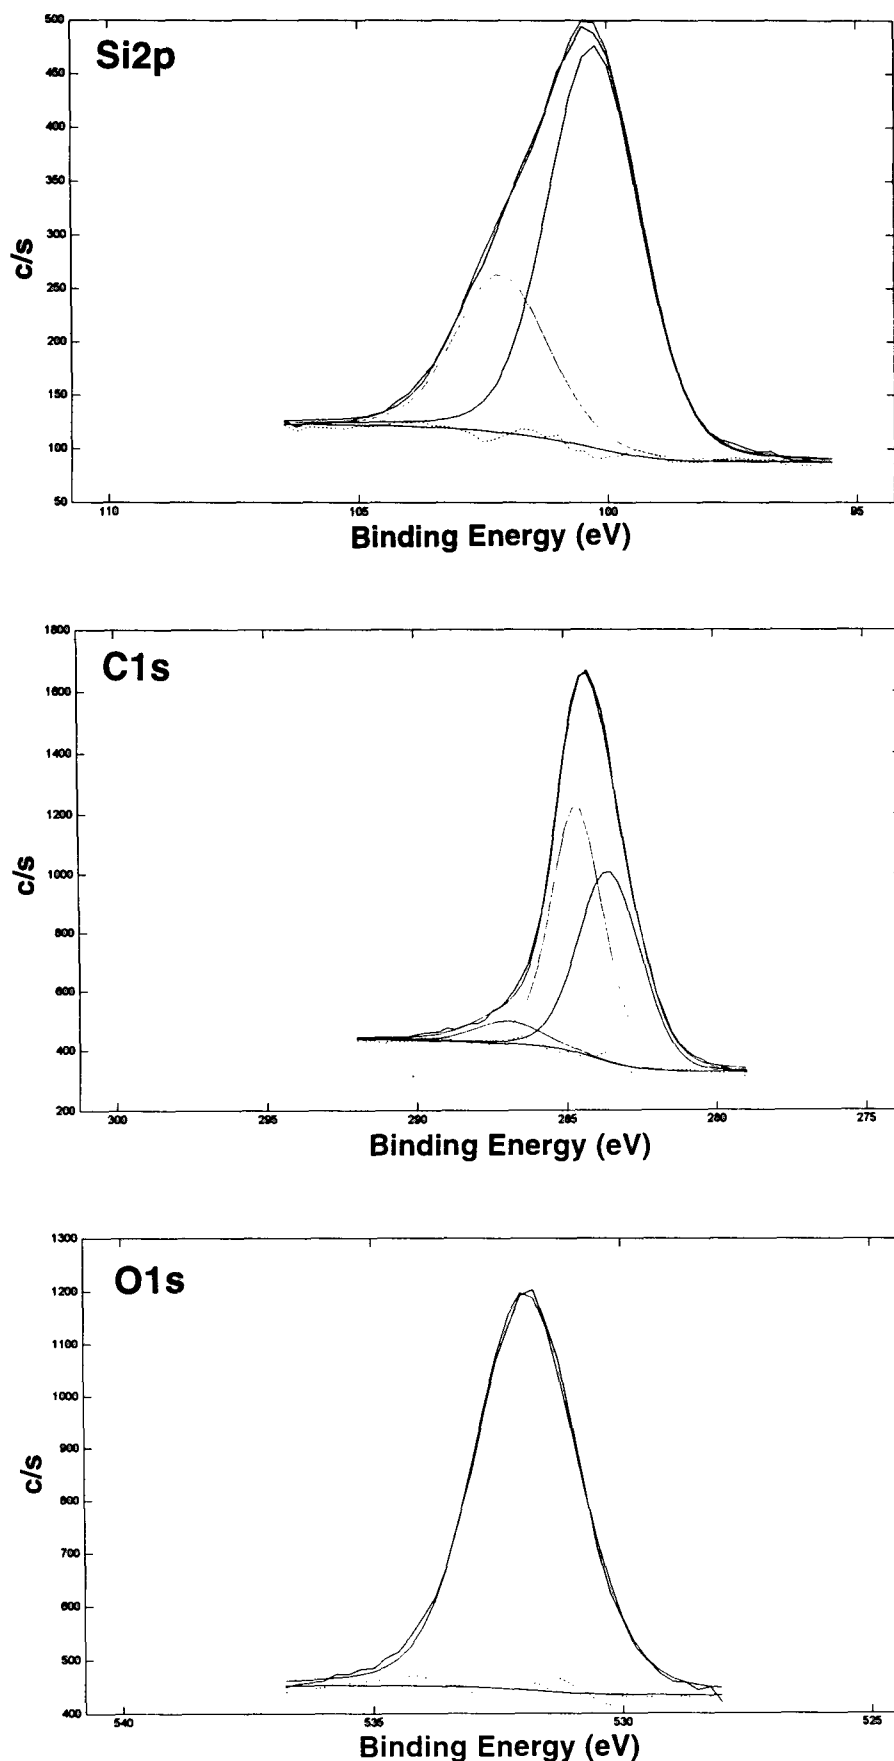
Figure 14. Deconvoluted Si, C and O spectral peaks of hexane+HF-washed and 0.2 Torr PO₂-tested Hexoloy SiC pin tip wear scar, in the as-tested+Ar-sputtered condition (also see Table 3). Ar-sputtering removed 1 nm. Peak assignments: Si2p peaks: 100.0 eV = carbidic, 102.2 eV = Si-O, silicates; C1s peaks: 282.7 eV = carbidic, 284.6 eV = graphitic, 286.7 eV = C-O, C=O; O1s peak: 532.0 eV = O-Si, organic carbonyls.

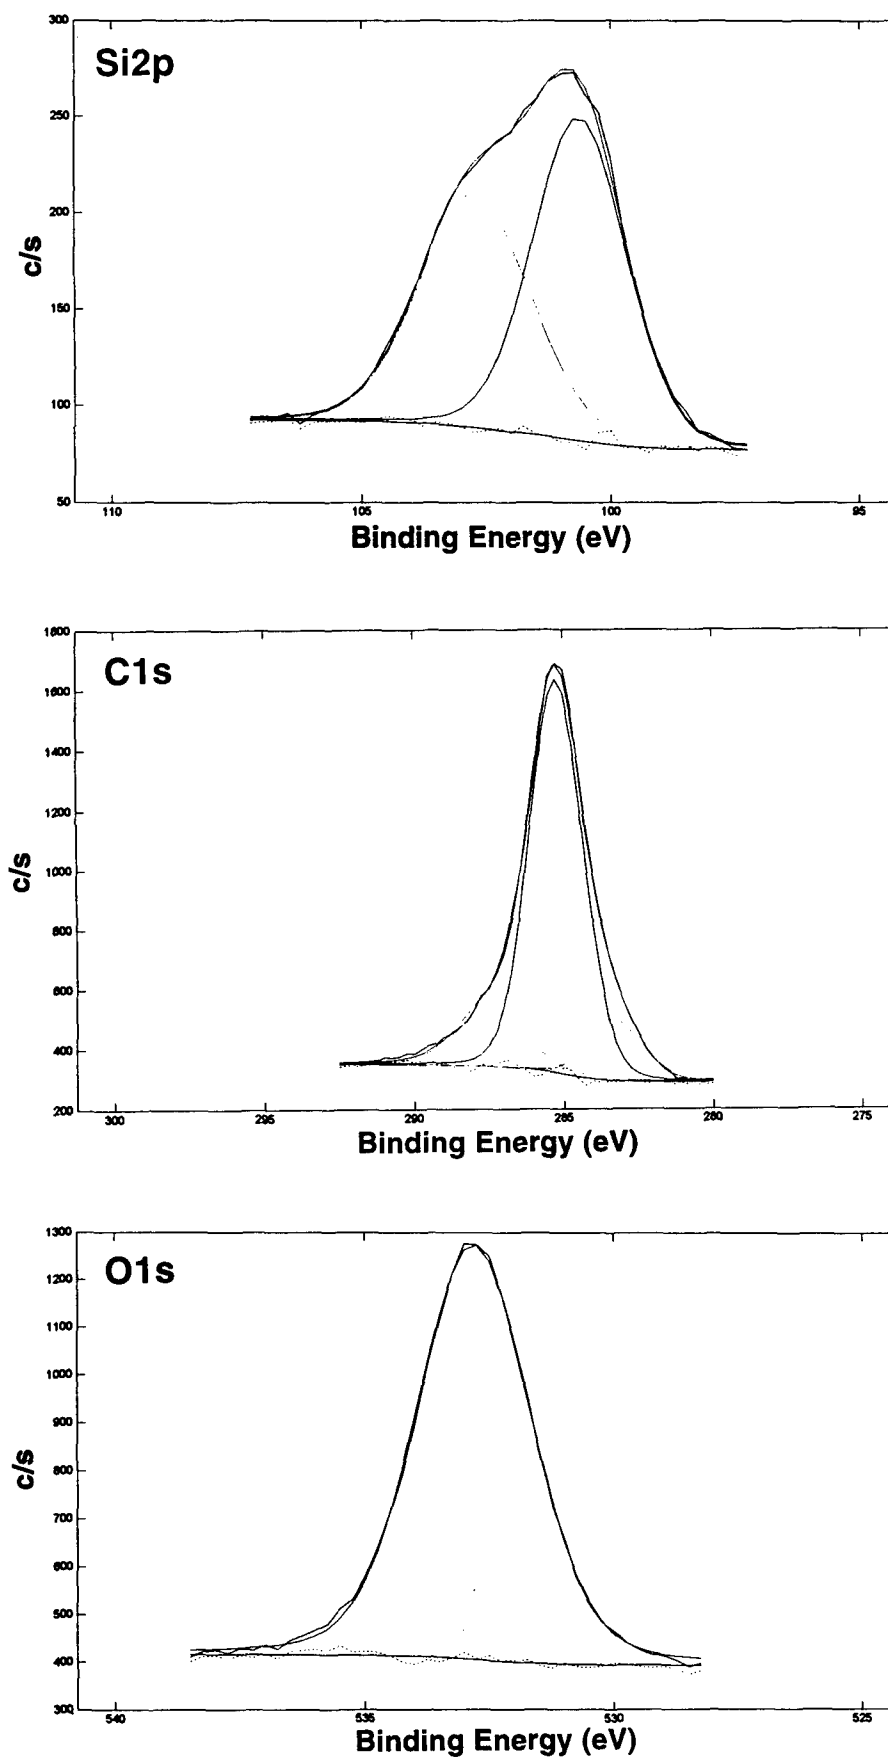
Figure 15. Deconvoluted Si, C and O spectral peaks of hexane+HF-washed and 0.2 Torr PO₂-tested Hexoloy SiC pin tip wear scar, in the wiped+Ar-sputtered condition (also see Table 3). Ar-sputtering removed 1 nm. Peak assignments: Si2p peaks: 100.0 eV = carbidic, 102.2 eV = Si-O, silicates; C1s peaks: 282.7 eV = carbidic, 284.6 eV = graphitic, 286.7 eV = C-O, C=O; O1s peak: 532.0 eV = O-Si, organic carbonyls.

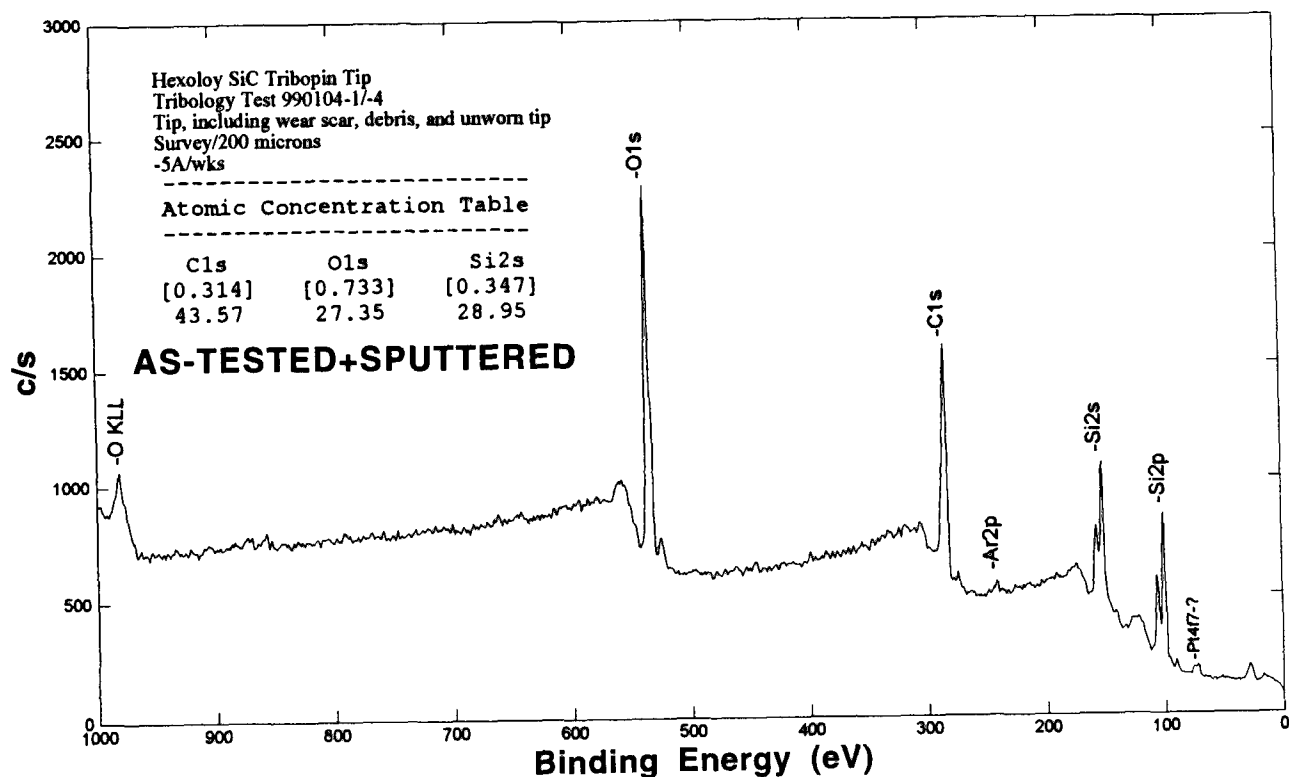
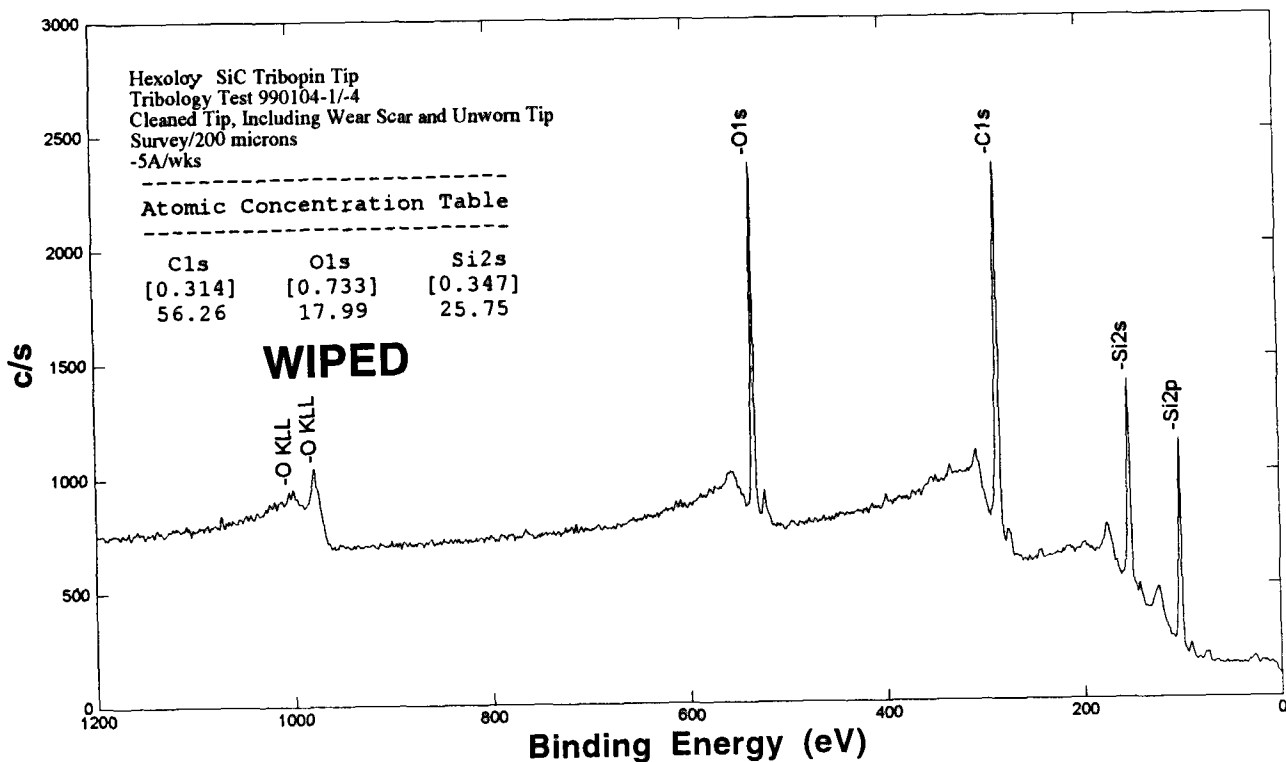
Figure 16. Wide-scan survey XPS spectra of the hexane+HF-washed and 3.4 Torr PO_2 -tested Hexoloy SiC pin tip wear scar, in the as-tested+Ar-sputtered (top) and wiped+Ar-sputtered (bottom) conditions; also see Table 4). Ar-sputtering removed 0.5 nm in each case.
